AIAA 98-3693

Shot-By-Shot Erosion Modeling Of Retired 120mm M256 Gun Tube #1988

S. Sopok, P. Vottis, P. O'Hara, G. Pflegl, C. Rickard US Army ARDEC-Benet Labs Watervliet, NY

34th AIAA/ASME/SAE/ASEE
Joint Propulsion Conference & Exhibit
July 13-15, 1998 / Cleveland, OH

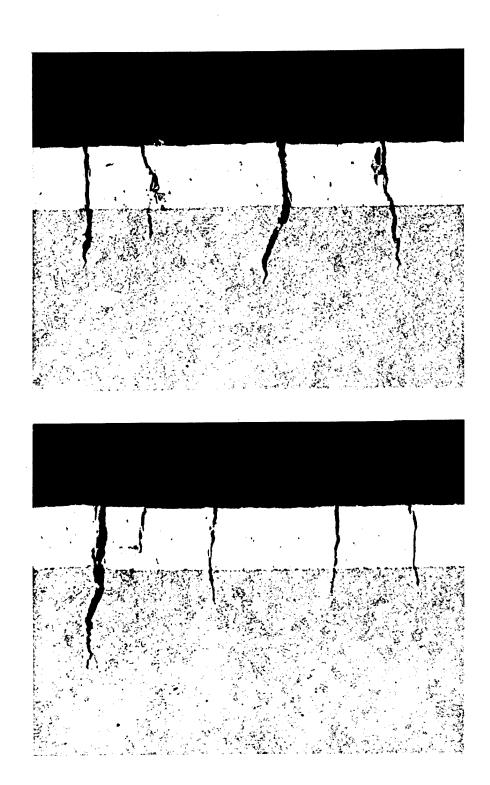
Fig 5 - Tube #1988 Metallographs At 0.69 m Representing 0.6-1.2 m Region

For M256 tube #1988, Figure 5 presents two typical 100x metallographs of a M256 tube with about half M829A2 and half M829 rounds at 0.69 meters RFT representing the 0.6-1.2 meter region. This 0.6-1.2 meter region has the highest gas pressure of any bore region (Figure 1) which explains the deep crack depths due to severe dilation. Although this 0.6-1.2 meter region has the highest gas temperature of any bore region (Figure 1), heat transfer to the wall is significantly diminished due to combustion case gas and vena contracta laminar cooling-turbulent mixing effects (Figure 2). These observations explain the heat checking and crack spacing as well as the near absence of interface degradation and chromium platelet spalling.

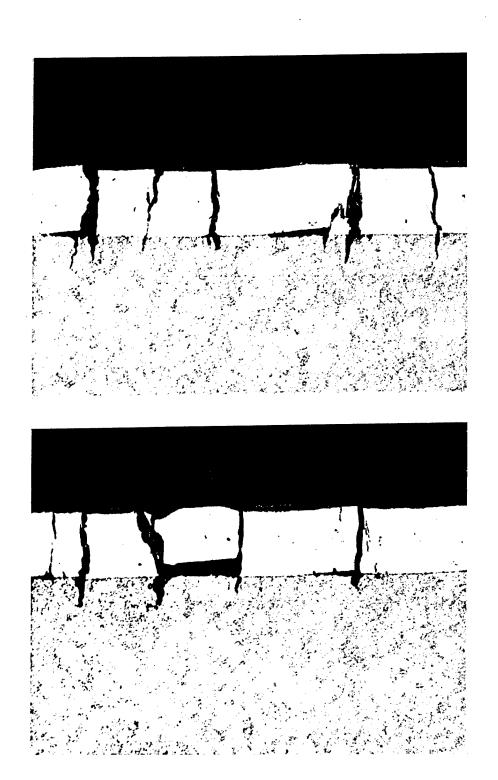
Fig 6 - Tube #1988 Metallographs At 1.55 m Representing 1.2-2.4 m Region

For M256 tube #1988, Figure 6 presents two typical 100x metallographs of a M256 tube with about half M829A2 and half M829 rounds at 1.55 meters RFT representing the 1.2-2.4 meter region. This 1.2-2.4 meter region has a lower gas pressure than the 0.6-1.2 meter region (Figure 1) which explains the

moderate crack depths due to moderate dilation. Although this 1.2-2.4 meter region has a lower gas temperature than the 0.6-1.2 meter bore region (Figure 1), heat transfer to the wall is significantly higher due to turbulent mixing of the combustion case gas and cessation of vena contracta effects (Figure 2). These observations explain the heat checking and crack spacing as well as the prevalent interface degradation and chromium platelet spalling. The erosion mechanism consists of heat checking of the inert chromium plate, subsequent interfacial degradation of the subsurface gun steel substrate at the chromium crack bases, subsequent chromium platelet spalling, and subsequent bare gun steel gas wash. As chromium platelets detach from the substrate and rise above attached chromium platelets, they are more susceptible to mechanical removal by the projectile. Rarely do heat checking cracks link-up to spall a chromium platelet with attached gun steel.

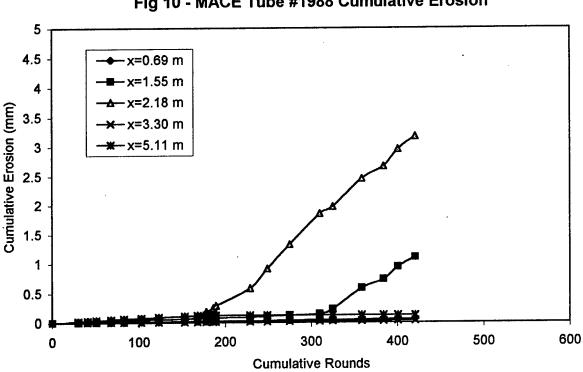
Fig 10 - MACE Tube #1988 Cumulative Erosion

For 120mm M256 gun tube serial number 1988, Figure 10 summarizes the MACE materialablation-conduction-erosion analyses for the cumulative erosion as a function of cumulative rounds and axial position. Selected axial positions, round types, and round conditioning temperatures are the same as in Figure 1. Tube #1988 was taken out-ofservice by dispersion at 424-rounds which is about seventy percent of its estimated erosion life. In Figure 10, the 2.18-meter RFT axial position is the most eroded position and has approximately 3mm of cumulative erosion at 424 rounds. If this gun tube remained in service, it should last an estimated 550 to 600 rounds before it was condemned by erosion at 5mm depth. The 2.18-meter position takes about 170 rounds for chromium platelet spalling onset and A723 gas wash onset to occur.

For Figure 10, cumulative wall erosion profiles follow the heat transfer pattern from Figure 2. This pattern includes the increase of cumulative wall erosion with increasing axial position for the 0.6-1.2 meter RFT region, the peaking of cumulative wall erosion in the 1.2-2.4 meter range, then the decrease of cumulative wall erosion with increasing axial

position to the muzzle. Again, this is due to combustion case gas and vena contracta laminar cooling-turbulent mixing effects. Erosion life is lowest at the 2.18-meter, higher at 1.55-meter, still higher at 0.69-meter, higher yet at 3.30-meter, and highest at 5.11-meter. These four Figures show that interface life follows the same pattern with the exception of the 5.11-meter position.

Also for Figures 10, the erosion mechanism consists of heat checking of the inert chromium plate, subsequent interfacial degradation of the subsurface gun steel substrate at the chromium crack bases, subsequent chromium platelet spalling, and subsequent bare gun steel gas wash. Mechanisms of interface degradation include diffusion, reactions, and gas wash. For example, sufficient iron oxidation formed at the chromium/A723 interface occupies a larger volume than the original iron and pushes up the chromium platelet leading to eventual chromium platelet spalling. This overall 120mm M256 gun tube serial number 1988 gun erosion analysis correctly predicts that the worst eroded region is at 1.2 - 2.4meters RFT and that the excessive muzzle wear at 5.11 m (chromium loss without gun steel gas wash) is by a different purely mechanical mechanism.
